CITY OF BALTIMORE WET WEA		Page 1 of 6				
Sewershed: OUTFALL	Company: REI/DRAYCO	Date: 09/30/2008				
Test Type: SMOKE	Ground Condition: Dry: X Damp:_ Wet:_	Supervisor: E.R.				
Manhole ID: S51II_036MH	Test ID: S1039-009	Notifications Made:X (Residents, Fire, 31				
ield Sketch: (Show all manholes with num	nbers, blower placement location, sandle locations, defect locations and photo		es, building addresses a			
1513 1511 1508 1509 1506 1507 1505 1503 1501 VIH	1509 1507 1505 1503 006MH	1508 1506 1504 1502 004MH	020M			
009_OB04_P01 009_OB03_P01 009_OB02_P01	034MH 1429 1427 1425 1428 1421 1419 1411 1411 1411	1422 1420 1418 1416 5 2 1414 5 1412	023 284.9 284.9			
009_OB01_P01	141	1410	N LINWOOD			
Legend Primary and Abandoned Sewers	140	1406				
Sewer Smoke Tested Sewer	140	1404	_ ~ \			
Manhole	14	1402				
Blower Location	036MH		SNO:			
Observation Location Area Not to Smoke Test Flow Basin Boundary Outfall Sewershed Boundary Plat Boundary		ver #1 II_036MH

Unique Test ID: S1039-009 Date: 09/30/2008 Manhole ID: S51II_036MH

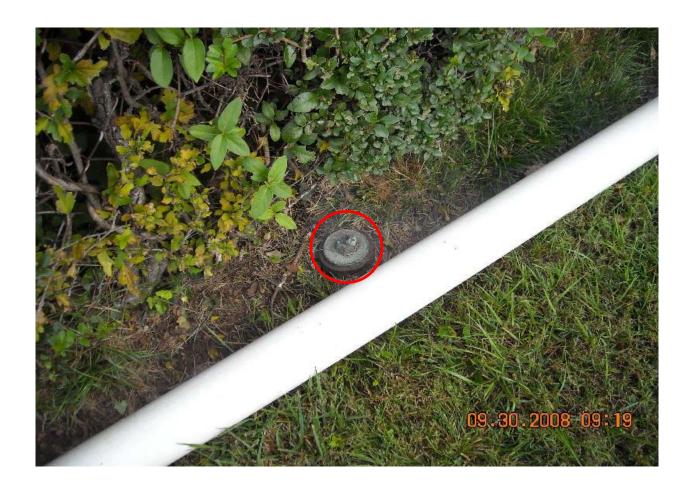
Photograph No: OB01-P01 Filename: S1039-009_OB01-P01.jpg

Defect No: OB01 Supervisor: E.R. Basin: Outfall

Location: 1409 KENHILL AVE.

Source Type: 03 Cleanout Sector: 02 Private

Location: 07 Yard - Front Severity: 03 Moderate Drainage Area: 1 ft²

Comments: Smoke is coming from an above grade cleanout with a broken cap.

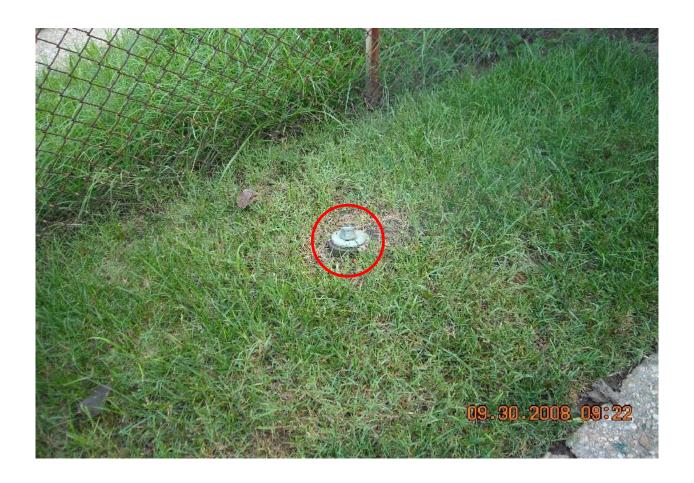
Photograph No: OB02-P01 Filename: S1039-009_OB02-P01.jpg

Defect No: OB02 Supervisor: E.R. Basin: Outfall

Location: 1421 KENHILL AVE.

Source Type: 03 Cleanout Sector: 02 Private

Location: 07 Yard - Front Severity: 03 Moderate Drainage Area: 1 ft²

Comments: Smoke is coming from an above grade cleanout with a broken cap.

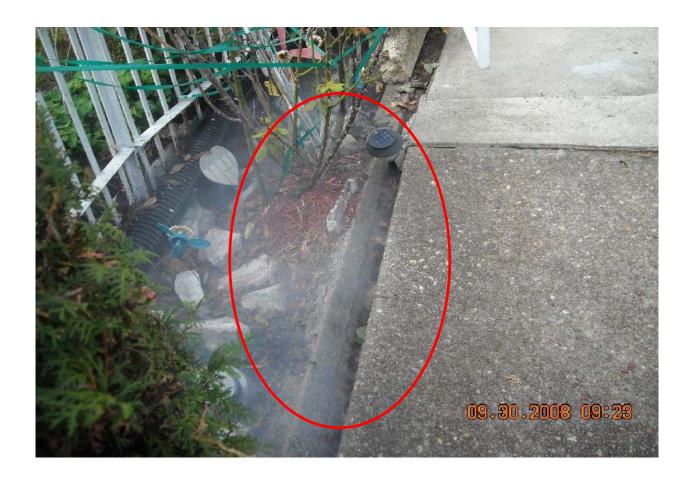
Photograph No: OB03-P01 Filename: S1039-009_OB03-P01.jpg

Defect No: OB03 Supervisor: E.R. Basin: Outfall

Location: 1429 KENHILL AVE.

Source Type: 02 Service Line Sector: 02 Private

Location: 07 Yard - Front Severity: 03 Moderate Drainage Area: 24 ft²

Comments: Smoke is coming from the edge of the sidewalk in front of 1429 Kenhill Ave.

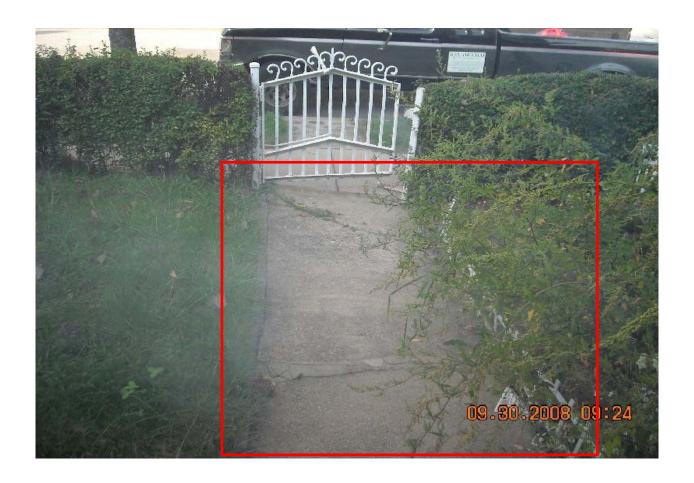
Photograph No: OB04-P01 Filename: S1039-009_OB04-P01.jpg

Defect No: OB04 Supervisor: E.R. Basin: Outfall

Location: 1431 KENHILL AVE.

Source Type: 02 Service Line Sector: 02 Private

Location: 07 Yard - Front Severity: 03 Moderate Drainage Area: 40 ft² Comments: Smoke is coming from the edges and cracks in the sidewalk in front of 1431 Kenhill Ave.
